Giordano-Bruno Cristinelli
Architect

COLLABORATION WITH MGHS LTD INTERIOR DESIGN FOR THE STUDY OF TWO LUXURY APARTMENTS London - U.K. Collaboration

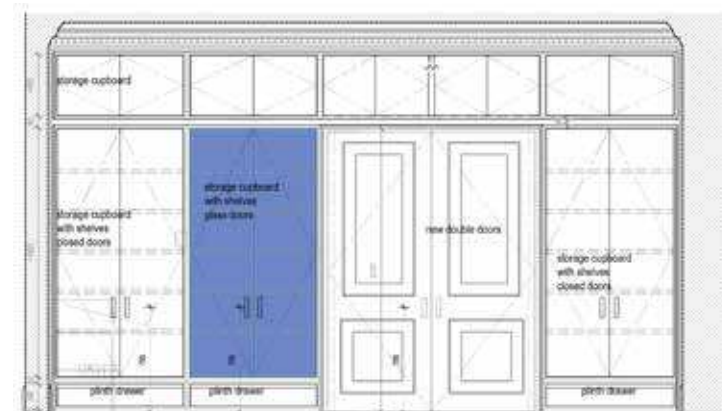
Elevation of the cupboard in the livingroom

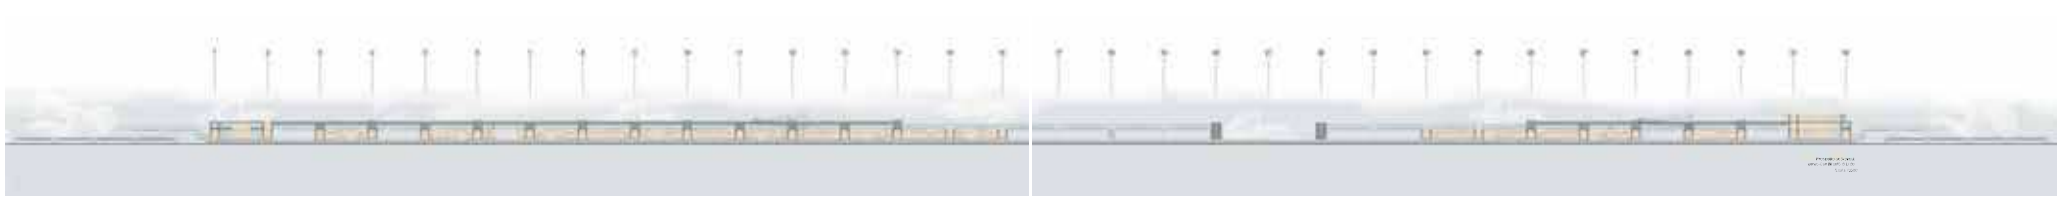
North-East Elevation.

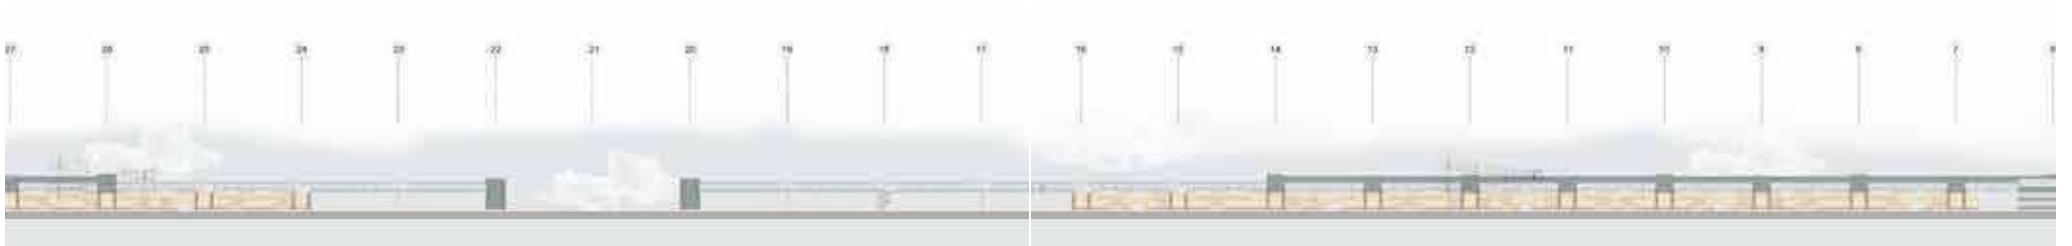
South-West Elevation - Detail.

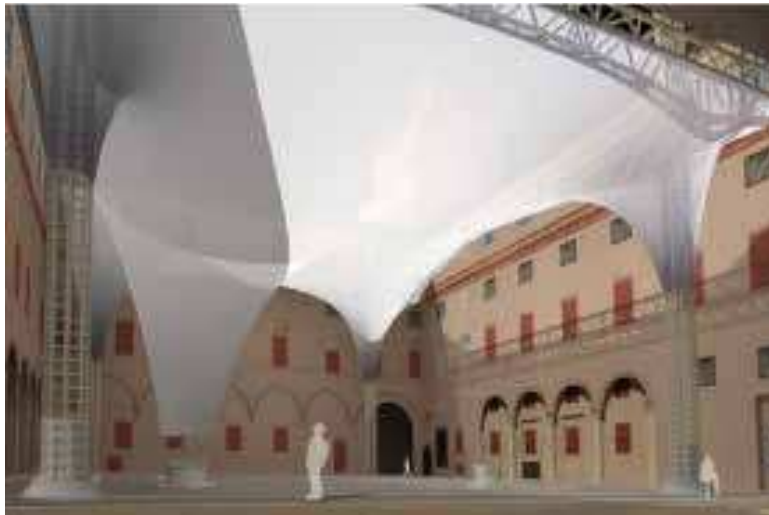
The temporary structure.

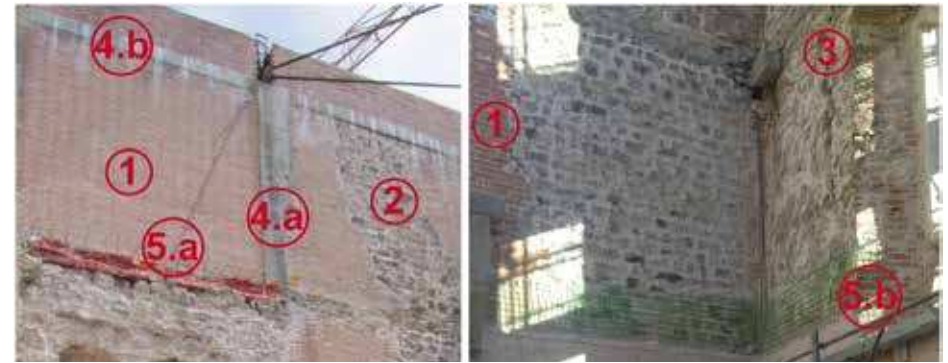
Integrations on the walls.

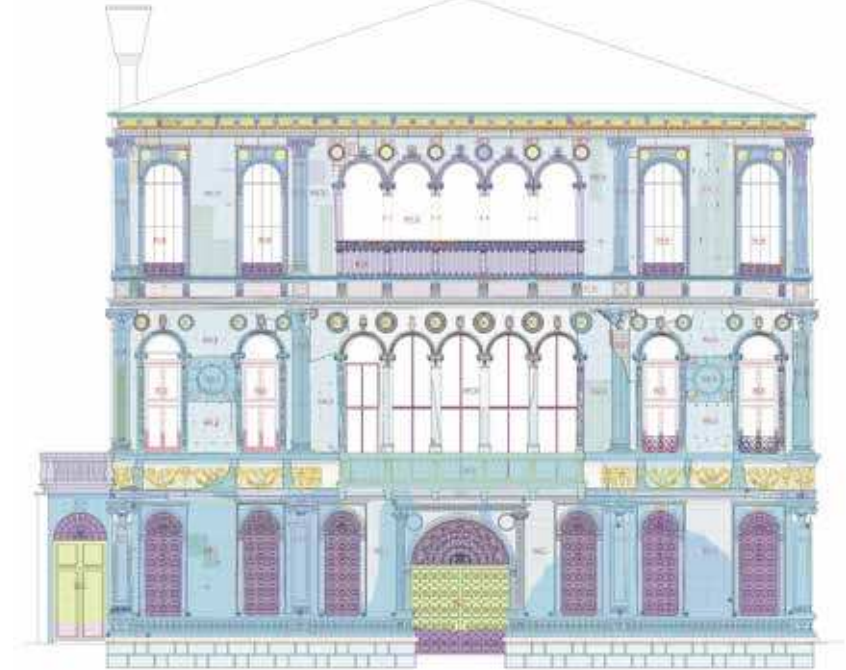
ANALYSIS OF DEGRADATION

SURFACE DEPOSIT	SPALLING
DISAGGREGATION	FILLING AND PATCHES
DETACHMENT	DEPOSIT PROTECTION OF ALTERED - FILM
EROSION	ROOT
FRACTURING or CRACKING	OXIDATION
STAIN	SPRAYING
LACK	EFFLORESCENCE
BIOLOGICAL FILM	CHROMATIC ALTERATION
CONCRETION	FILM
CRUST	ENCrustATION
DEFORMATION	DIFFERENTIAL DETERIORATION
WOODBORING ATTACK	* PRESENCE OF VEGETATION

Legend of degradation

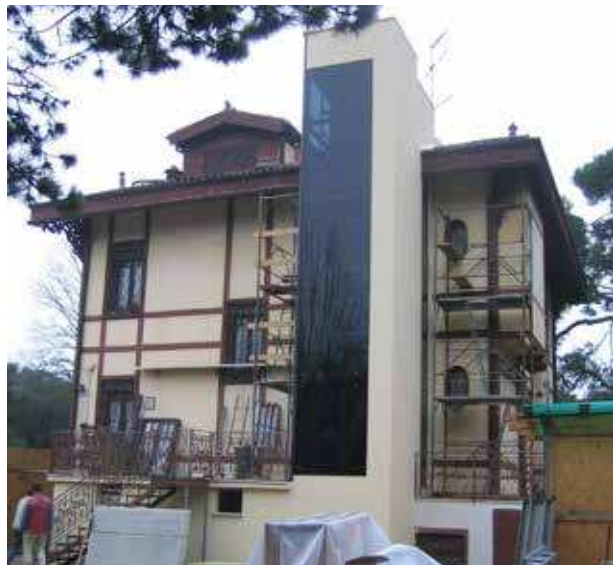
Elevation on the faciade of the new elevator.

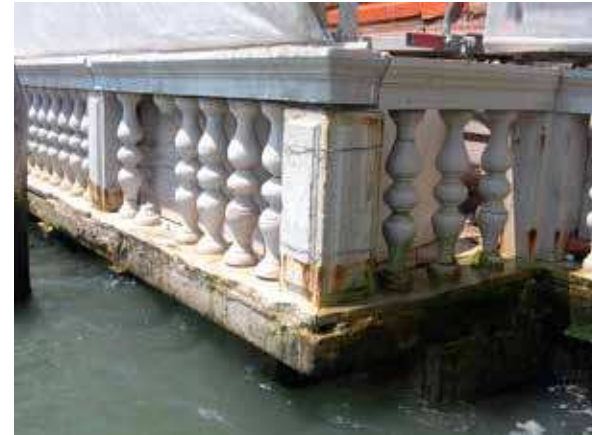
Degradation of the terrace in Istrian stone.
